Technical Bulletin

Model(s)	Year	Eng. Code	Trans. Code	VIN Range From	VIN Range To
Golf, Jetta, Jetta Wagon	1999 - 2003	1.9L (ALH)	All	All	All
New Beetle	1998 - 2003	1.9L (ALH)	All	All	All

21 07 04 April 23, 2007 2012043 Supersedes T. B. Group 21 number 06 01 dated Dec. 5, 2006 due to change in actuator hose clamp part number and updated labor operation number.

Customer Complains of Poor Acceleration - Insufficient Turbo Boost

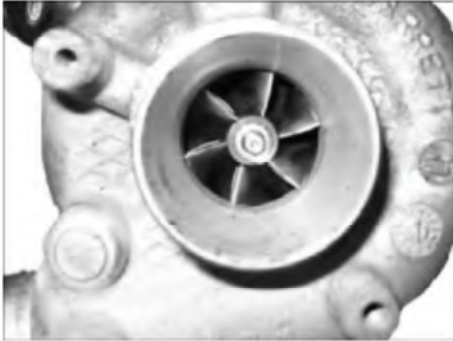
Inspection of turbine

- Check turbocharger (intake side) and turbine for visible damage or contact with housing.
- Check for high resistance when rotating turbine impeller.

Some lateral and horizontal movement of the compressor wheel/impeller is normal and does not indicate a failed or failing turbocharger.

If high resistance is felt or damage is present, replace turbocharger.

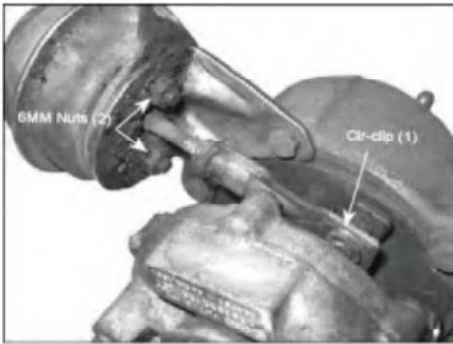
Inspection of variable vane linkage

Ensure smooth and free movement of the rotary vane lever / linkage once actuator is removed from turbocharger assembly. If the rotary vane lever does not operate properly, replace turbocharger.

- Obtain special tool VAS 6122.
- Plug all openings of turbo charger to prevent entry of dirt.
- Remove snap-ring / Cir-clip (1) and 6mm nuts (2).
- Remove actuator.

A 10MM, 6 point, box end wrench is recommended for removal of actuator retaining nuts due to possible corrosion of nuts and/or studs. This will prevent the rounding of the nuts

- Clean surface of bracket with sand paper until corrosion free.

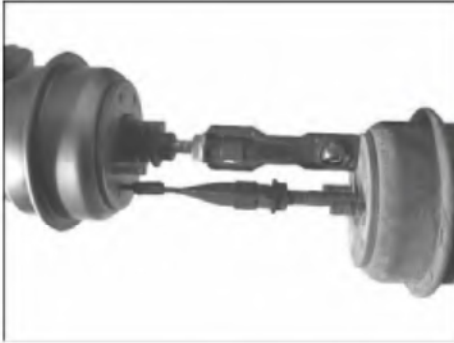
Installing new actuator

! Note: If actuator has seized in the compressed position a rough thread count at the adjuster sleeve locknut should be used for initial adjustment before installing.

- Adjust the new actuator to same length as original, as shown above, to obtain initial adjustment.

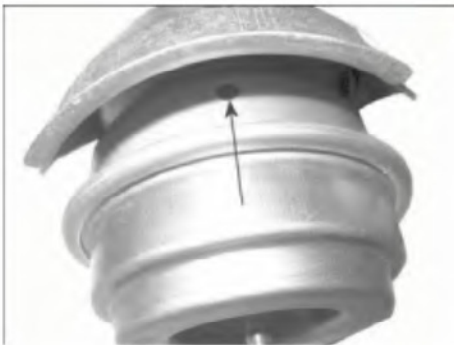
The vent hole on the actuator should be covered by the shield and always face the exhaust side of the turbocharger.

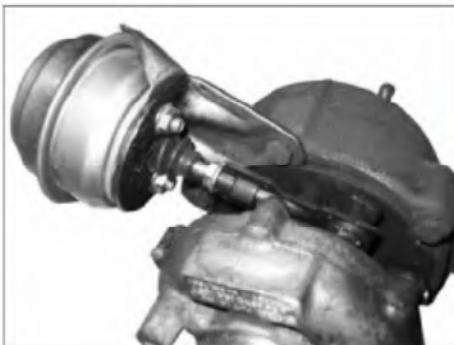
Ensure snap-ring / Cir-clip retaining actuator actuation arm is properly engaged in rotary vane lever.

- Install new actuator tighten nuts to 6 N.m (53 in. lbs), install new snap-ring / cir-clip.

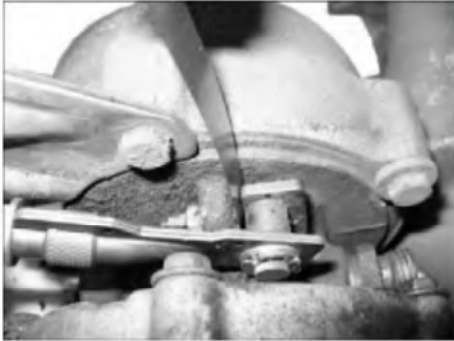
Calibrating turbocharger other than recommended DOES NOT enhance vehicle performance and may lead to premature failure of turbocharger or other related powertrain components.

- With a 0.05 mm (.002 in.) feeler gauge inserted between the stop and the vane linkage, apply minus 600 mbar \pm 20 mbar (17-18.5 in.) of vacuum to actuator.
- At 17 in. the feeler gauge should move freely. Resistance should be felt on the feeler gauge at 17.5 and at 18 in. of vacuum the vane linkage should retain the feeler gauge
- At 18 in. of vacuum the arm shall contact the stop and the feeler gauge should not be able to be inserted.
- Apply -600 mb (18 in.) of vacuum to actuator.
- Check clearance between linkage and stop.
- Adjust clearance to 0.05 mm (.002 in.) @ 600 \pm 20 mbar (18 in.) vacuum.
